Building Resilience: Lessons from a Decade on Comanche Creek, Valle Vidal, New Mexico

by Avery C. Anderson, Tamara Gadzia and Courtney White

Since 2001, the Quivira Coalition has directed a public lands riparian restoration project within the 27,430-acre (43 square-miles) Comanche Creek watershed which lies in the heart of the 100,000-acre Valle Vidal Unit of Carson National Forest in north-central New Mexico. Our goal has been to build long-term resilience and restore habitat for the Rio Grande cutthroat trout (RGCT). In this article, we attempt to answer two questions: Are we succeeding? And what lessons have we learned that might help

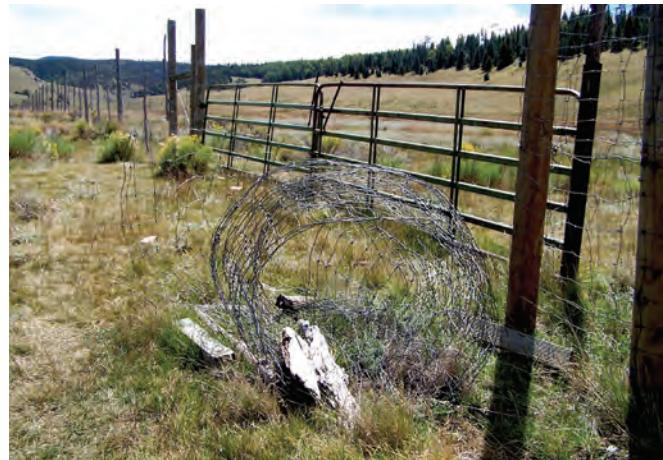
Large enclosure showing gate and fence, September 2005. Questa Ranger District and volunteers are in the process of decommissioning this structure.

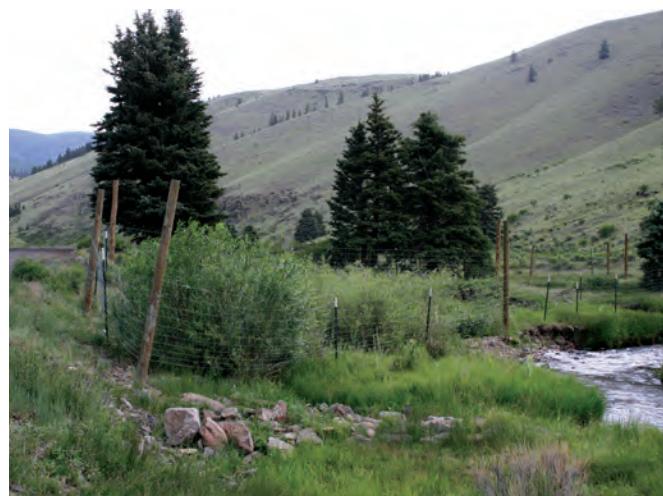
Thriving willows and other riparian species in mini-exclosure, July 2008.

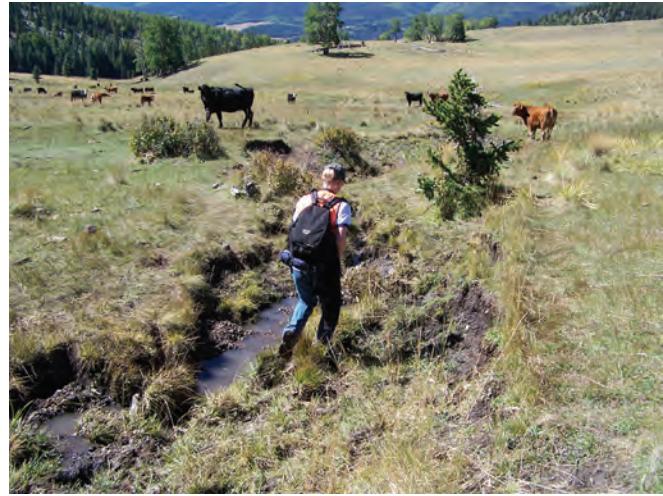
Documenting headcuts and gully formation on the upper reach of Springwagon Creek, a tributary of Comanche Creek, September 2005. This tributary exhibits "hot spots" due to trampling by cattle.

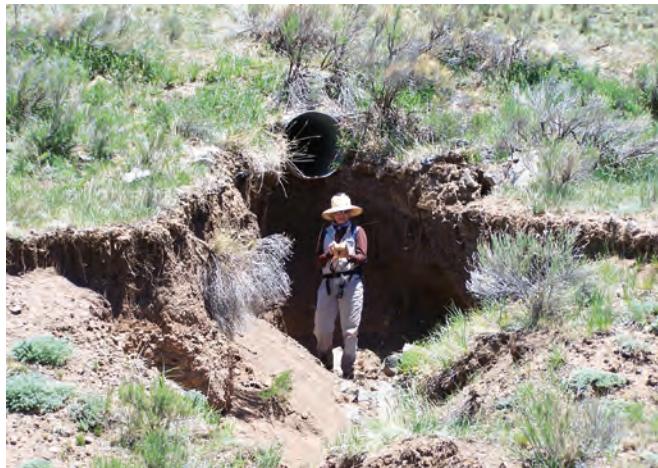
Documenting the condition of road drainage structures and their contribution to sediment supply in Comanche Creek, June 2005.

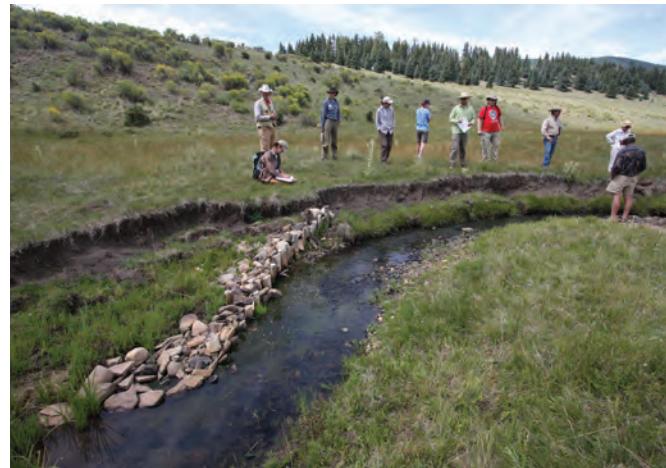
Monitoring the condition and effectiveness of a post vane bank stabilization structure on the middle reach of Comanche Creek, August 2011.

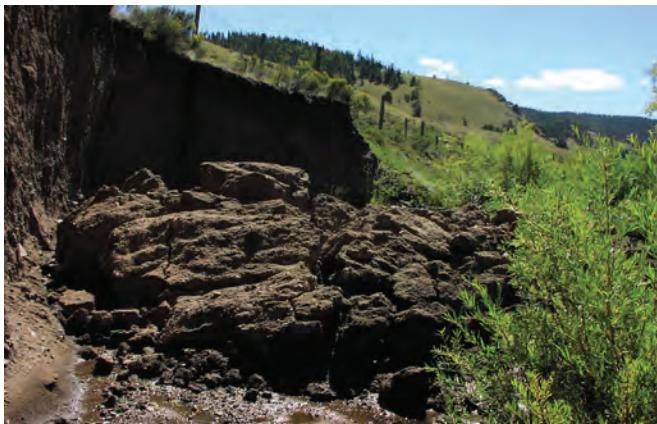
Before treatment, this one cutbank along Comanche Creek was contributing 110 to 120 cubic yards of sediment per year, September 2004.

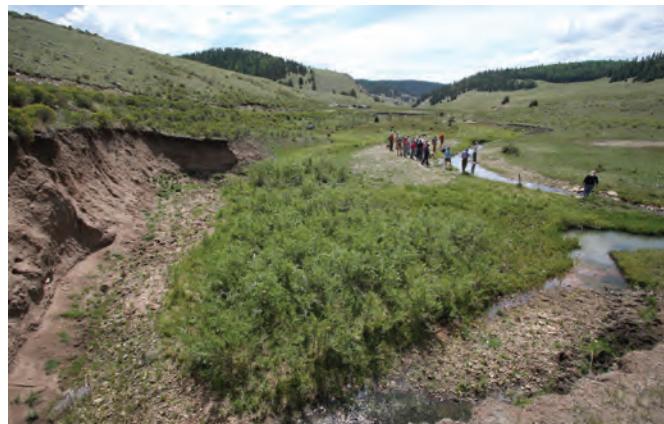
This section of the creek was treated by realigning the channel to the opposite side of the willow stand. Now the willow stand acts as a buffer between the creek and the eroding bank, August 2011.

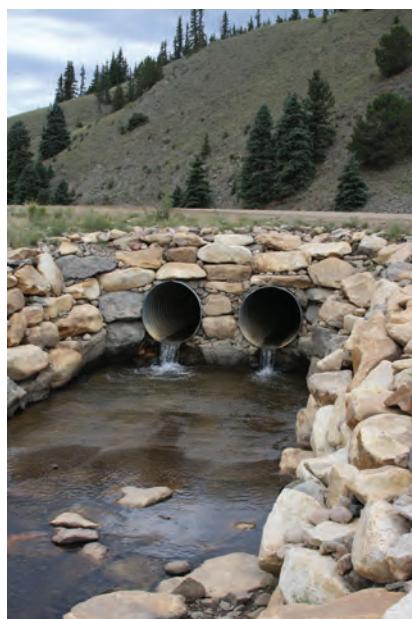
Fish barrier where Comanche Creek crosses Forest Road 1950.

In tandem with our habitat restoration work, the New Mexico Department of Game & Fish installed a fish barrier along Comanche Creek in 2006. The intent of the fish barrier was to isolate the native RGCT from other non-native trout species that can genetically

out-compete their native counterparts. After installing the fish barrier, the NMDG&F spent two years removing all non-native fish from this upstream creek barrier, thus achieving a significant milestone in the recovery process for the RGCT in Comanche Creek.

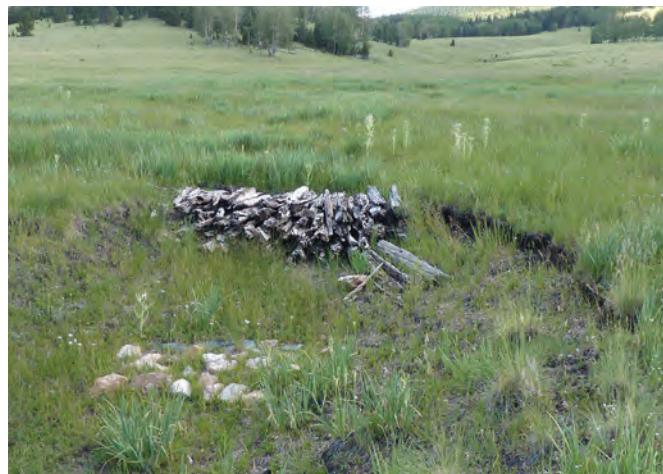
A headcut in Holman Meadow was healed using a log and fabric step falls structure, July 2010.

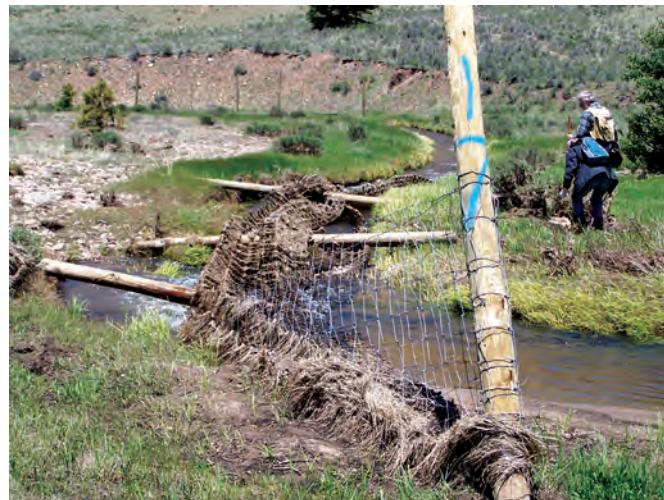
Eighty percent of mini-exclosures along Comanche Creek were damaged during the flood of 2005 and again in 2010 (June 2005). Construction, installation and location protocols were adapted to withstand future high water events.

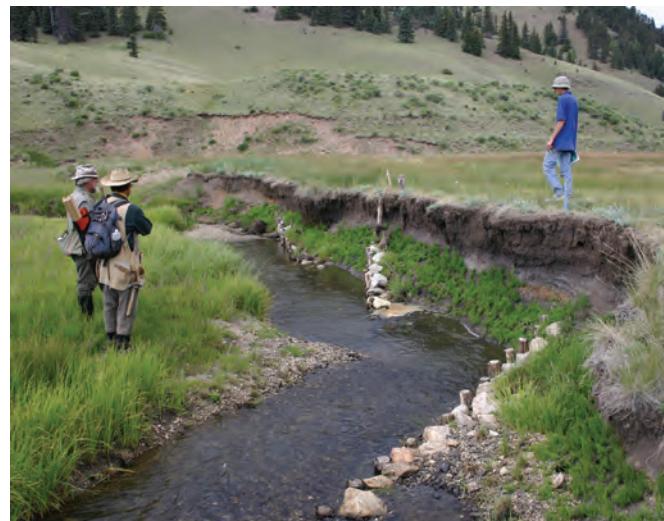
Assessing post van performance, July 2008.

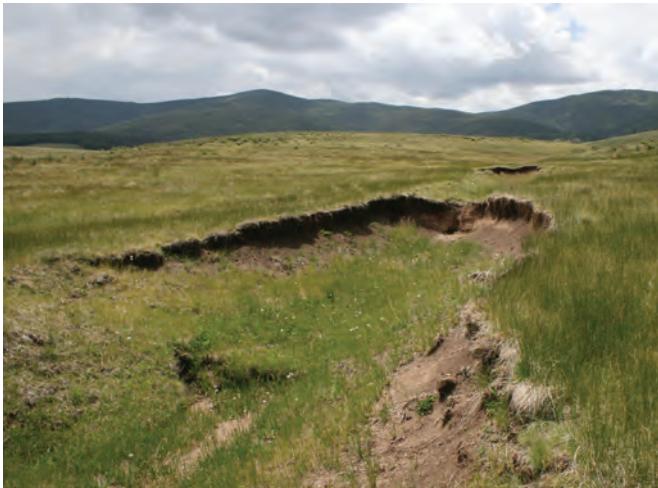
Headcuts unzipping the La Belle wet meadow drainage of Comanche Creek, July 2008.

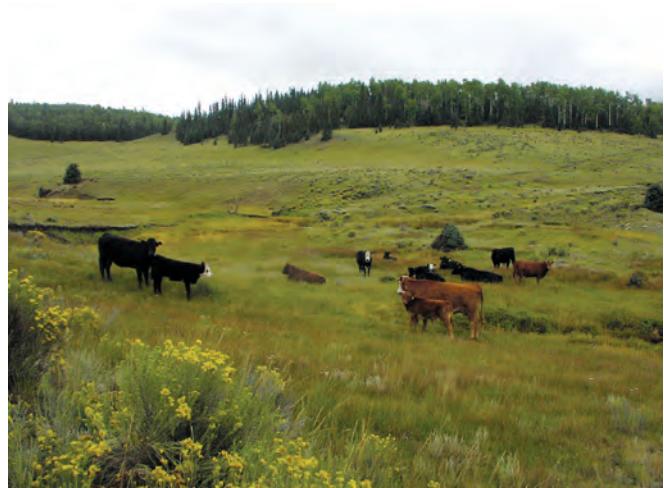
Cattle in the Comanche Creek riparian area, September 2006.
