The Gift

Courtney White

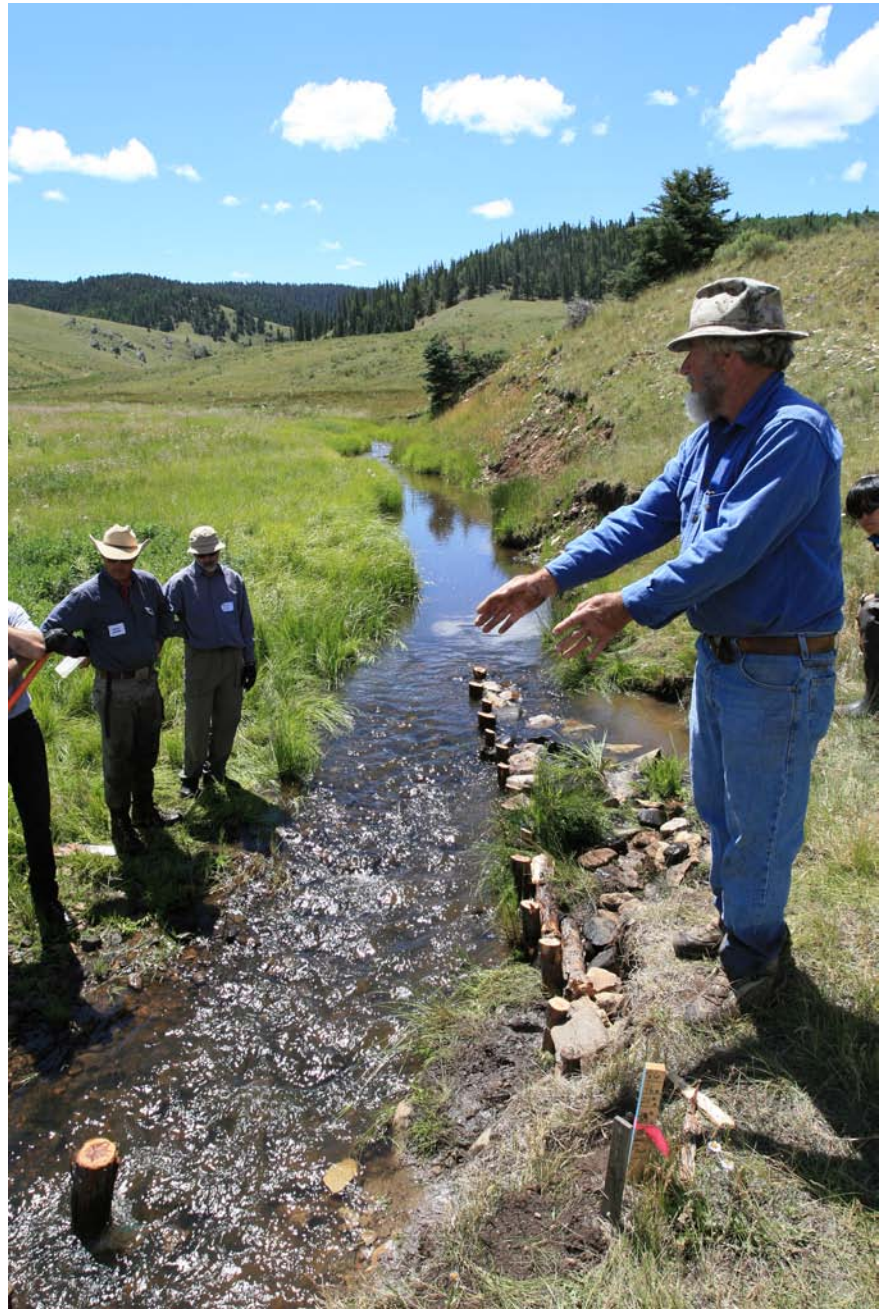
Riparian restoration specialist Bill Zeedyk stands on a bank of Comanche Creek explaining how a post vane structure works, July 2007. Photo by Courtney White

Quivira Coalition, and numerous others—more than sixty people in all. The goal for the weekend was to construct nearly two dozen vanes—wooden posts that are placed vertically in the creek, at a wedge-shaped angle to the bank, so that water is deflected away from the eroded edge of the creek. They’re quick to build and rather fun to install, because it involves getting muddy. Before long one morning, everyone was busy hauling, hammering, or digging. Laughter and high spirits filled the meadow.

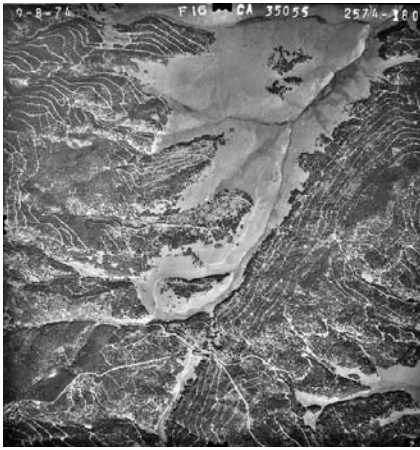
An aerial view of the upper Comanche Creek watershed taken in 1974 reveals the effects of hundreds of miles of logging roads. Photo courtesy of the Quivira Coalition

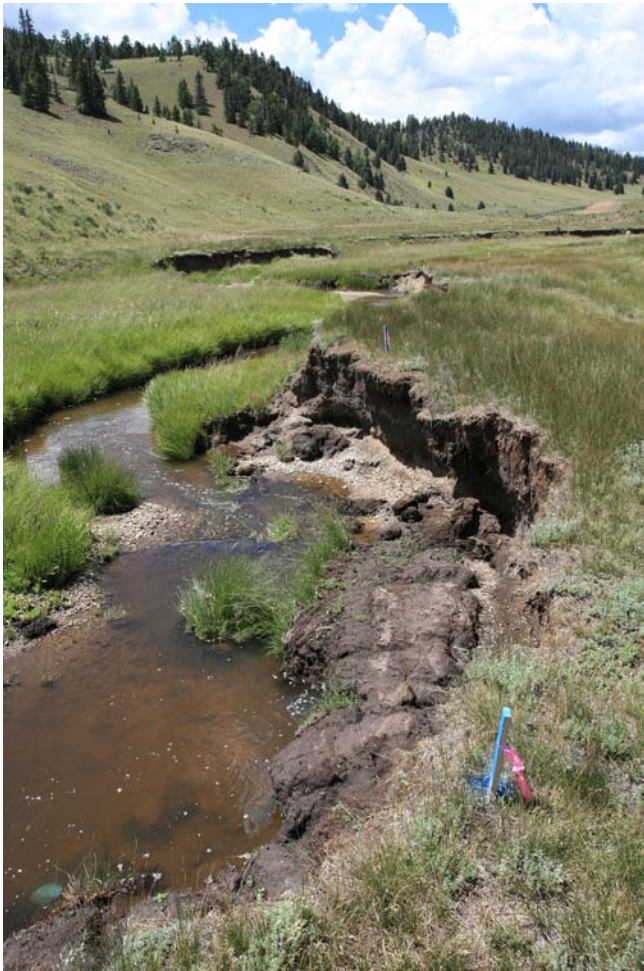
A legacy of heavy use in the Comanche Creek watershed has caused stream banks to become unstable, causing increased sedimentation. Photo by Courtney White

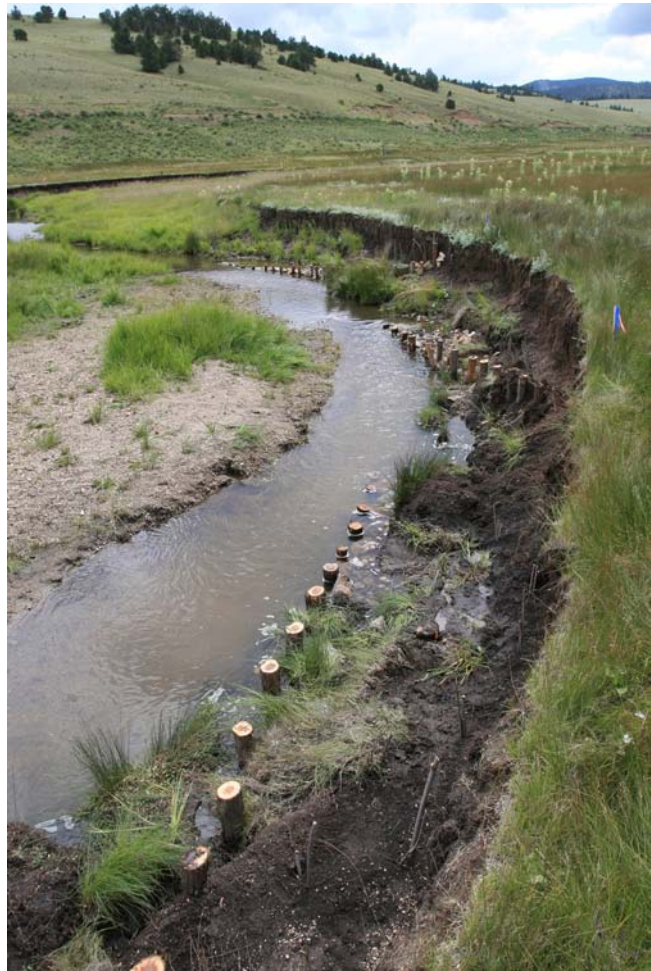
Three post vane structures help heal the creek by moving the water flow away from eroding banks on the outside bend (note the willow cutting planted behind the vanes, which will help build a new bankfull bench). Photo by Courtney White

Raw Streambanks: Under Bill’s guidance, a large quantity of erosion control structures was proposed to be constructed within the watershed, including wooden vanes and baffles in the creek itself, one-rock dams in the uplands, and worm ditches, rock baffles, and headcut control features in wet meadows. The purpose

of these structures was to speed up natural recovery processes. Scouring by erosion caused by historic overgrazing and logging resulted in the creek cutting down below its traditional floodplain. Over time, the creek had begun to heal itself by creating a new floodplain—“remeandering” itself to dissipate energy and drop sediment—but there were plenty of old “wounds” that had not healed. The goal of the restoration work was to “goose” the healing process along gently.

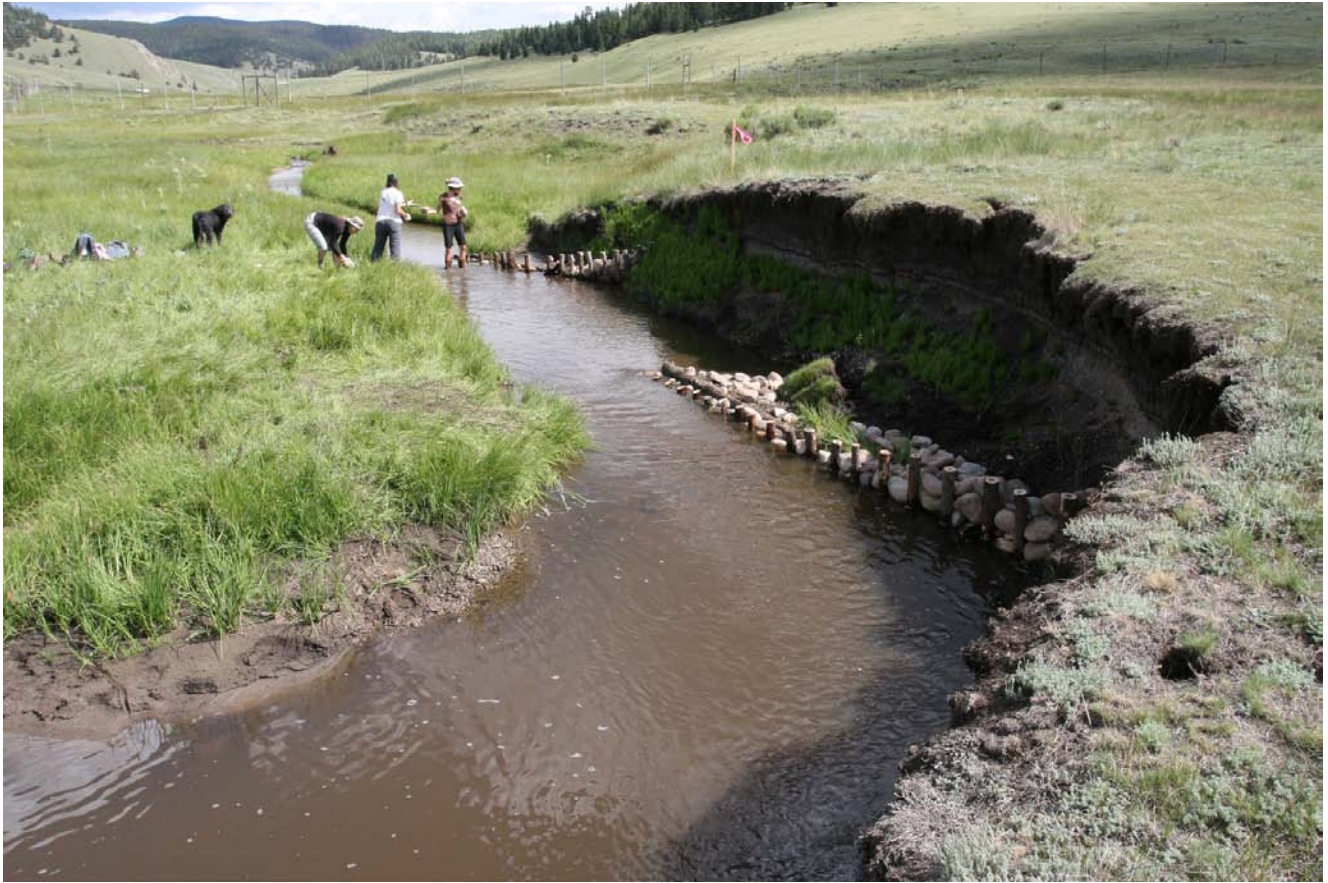
Volunteers use rocks to fill in behind a post vane structure in Comanche Creek (view upstream). Photo by Courtney White

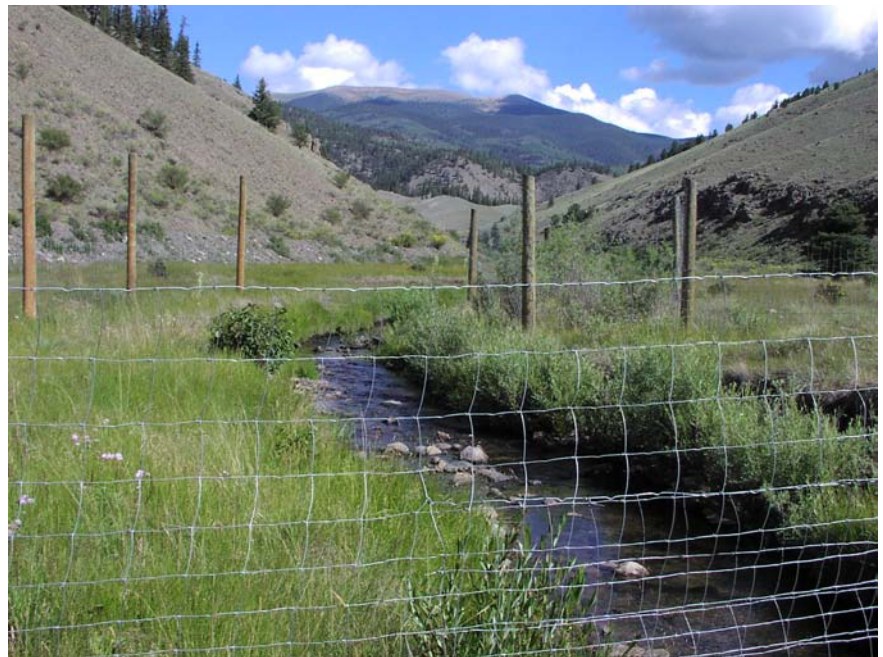
An herbivore exclosure under construction, one of fifty built since the mid-1990s to protect native vegetation along Comanche Creek. Photo by Bill Zeedyck

existing native willow clumps to protect them from grazing animals. This was in contrast to the big elk enclosure built in the 1980s on the creek, which proved difficult to maintain.

The mini-exlosures were deemed a success. So the working group, with the energetic assistance of the Rocky Mountain Youth Corps, which employs “at-risk” youth from the Taos area, decided to build many more elk enclosures. The goal was to protect the willows so they could grow and shade the water, thus reducing overall stream
