The Gift

Courtney White

“The Gift” is an excerpt from Chapter 10 in Courtney White’s new book Revolution on the Range: the Rise of a New Ranch in the American West. A former archaeologist and Sierra Club activist, Courtney White voluntarily dropped out of the “conflict industry” in 1997 to cofound The Quivira Coalition, a nonprofit dedicated to building bridges between ranchers, conservationists, public land managers, scientists and others around the idea of land health (www.quiviracoalition.org). Since then, his work has expanded to include restoration, resilience, and local food production. In 2008, Island Press published Courtney’s book Revolution on the Range: the Rise of a New Ranch in the American West (www.islandpress.org/bookstore/details.php?prod_id=1233). He can be contacted at executive@quiviracoalition.org. In the fall of 2009, The Quivira Coalition will publish Let the Water Do the Work: Induced Meandering, an Evolving Method for Restoring Incised Channels by Bill Zeedyk and Van Clothier.

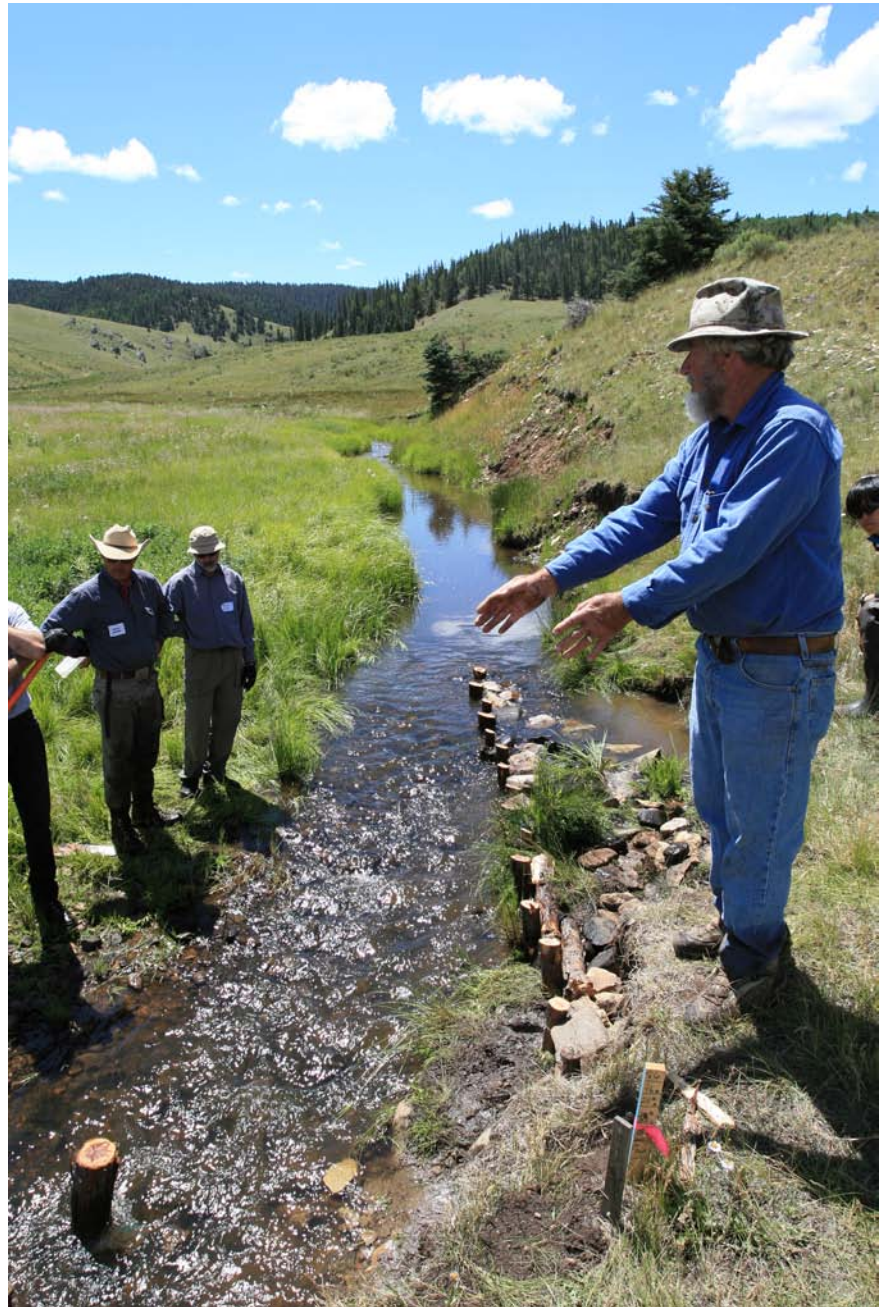
Riparian restoration specialist Bill Zeedyk stands on a bank of Comanche Creek explaining how a post vane structure works, July 2007. Photo by Courtney White

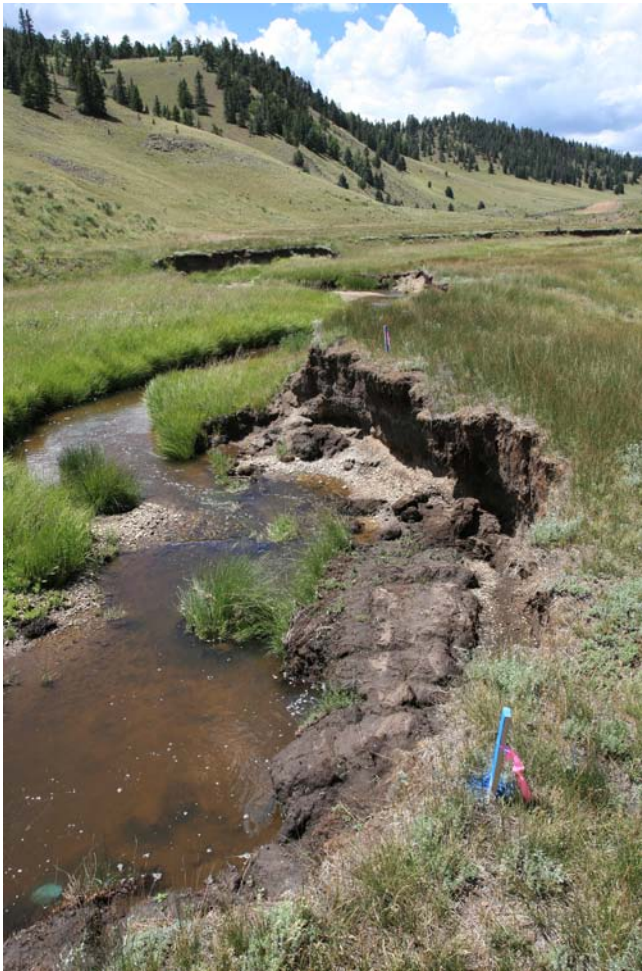
A legacy of heavy use in the Comanche Creek watershed has caused stream banks to become unstable, causing increased sedimentation. Photo by Courtney White

of these structures was to speed up natural recovery processes. Scouring by erosion caused by historic overgrazing and logging resulted in the creek cutting down below its traditional floodplain. Over time, the creek had begun to heal itself by creating a new floodplain—“remeandering” itself to dissipate energy and drop sediment—but there were plenty of old “wounds” that had not healed. The goal of the restoration work was to “goose” the healing process along gently.

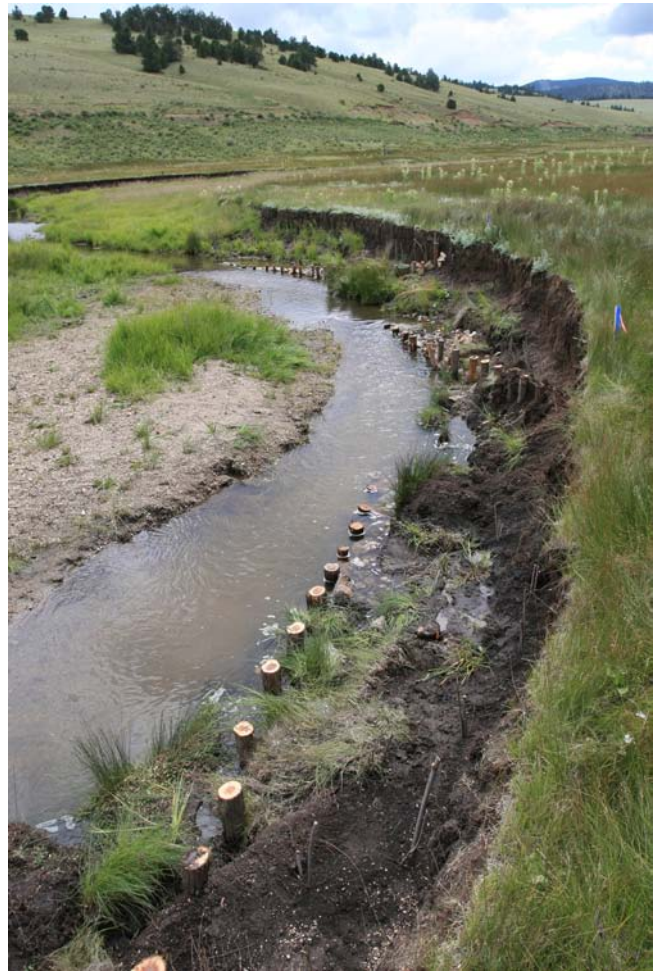
Three post vane structures help heal the creek by moving the water flow away from eroding banks on the outside bend (note the willow cutting planted behind the vanes, which will help build a new bankfull bench). Photo by Courtney White

Quivira Coalition, and numerous others—more than sixty people in all. The goal for the weekend was to construct nearly two dozen vanes—wooden posts that are placed vertically in the creek, at a wedge-shaped angle to the bank, so that water is deflected away from the eroded edge of the creek. They’re quick to build and rather fun to install, because it involves getting muddy. Before long one morning, everyone was busy hauling, hammering, or digging. Laughter and high spirits filled the meadow.

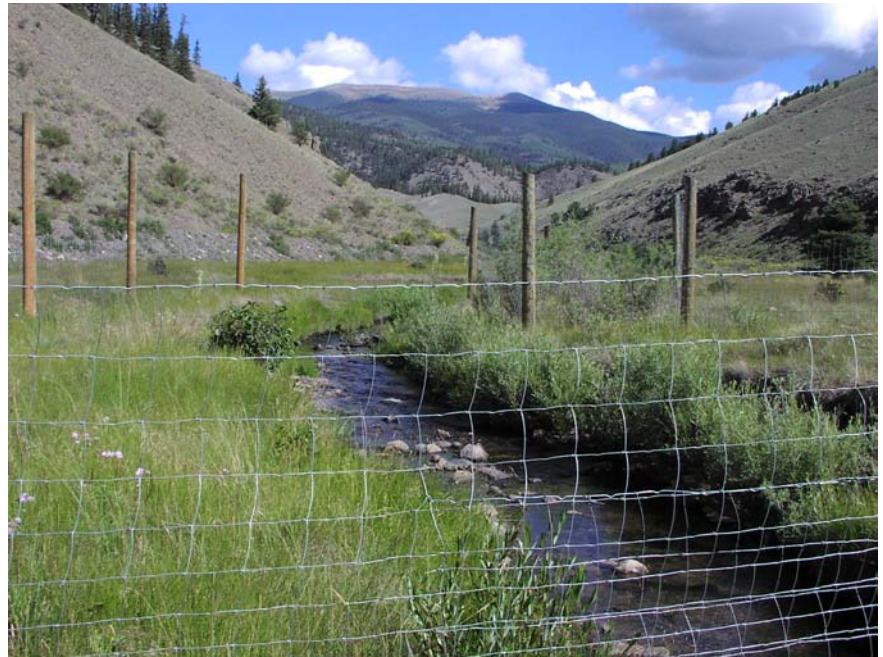
An herbivore exclosure under construction, one of fifty built since the mid-1990s to protect native vegetation along Comanche Creek. Photo by Bill Zeedyck

Hungry Animals: Although the cattle were largely controlled by a range rider, our monitoring showed that cattle-caused “hot spots”—usually areas that had been excessively trampled—still could be found in the riparian area. Elk had grazed the area too. And both animals are very fond of young willows and cottonwood trees. In the mid-1990s, the Forest Service experimented with a novel idea: create house-sized “mini-exlosures” around

existing native willow clumps to protect them from grazing animals. This was in contrast to the big elk enclosure built in the 1980s on the creek, which proved difficult to maintain.

The mini-exlosures were deemed a success. So the working group, with the energetic assistance of the Rocky Mountain Youth Corps, which employs “at-risk” youth from the Taos area, decided to build many more elk exclosures. The goal was to protect the willows so they could grow and shade the water, thus reducing overall stream
